Caloosahatchee Estuary - Oysters

Caloosahatchee Estuary – CRE 2 Submerged Aquatic Vegetation

Caloosahatchee Estuary – CRE 8 Seagrass

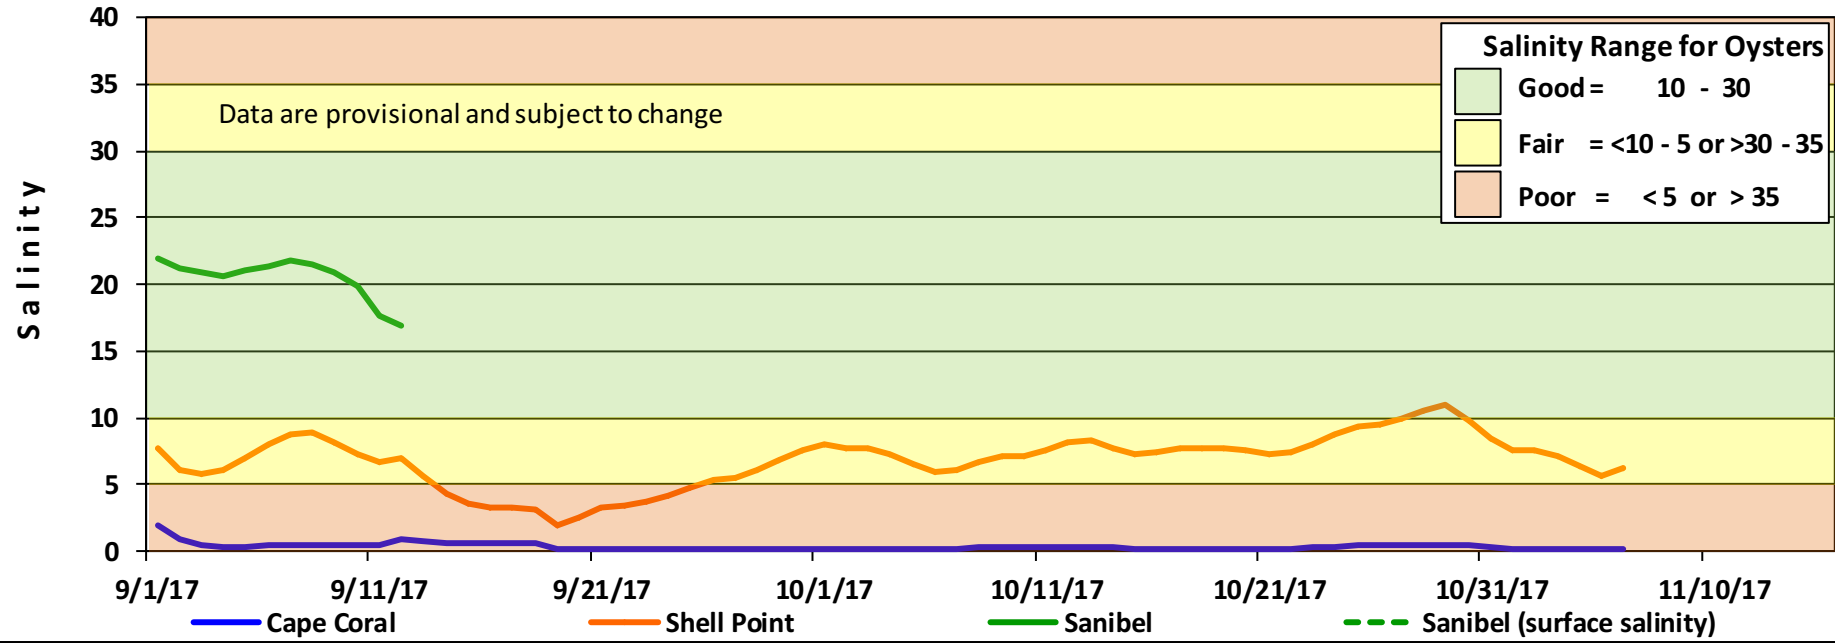
Seven day mean salinity of the water column at 3 monitoring stations in the Caloosahatchee Estuary

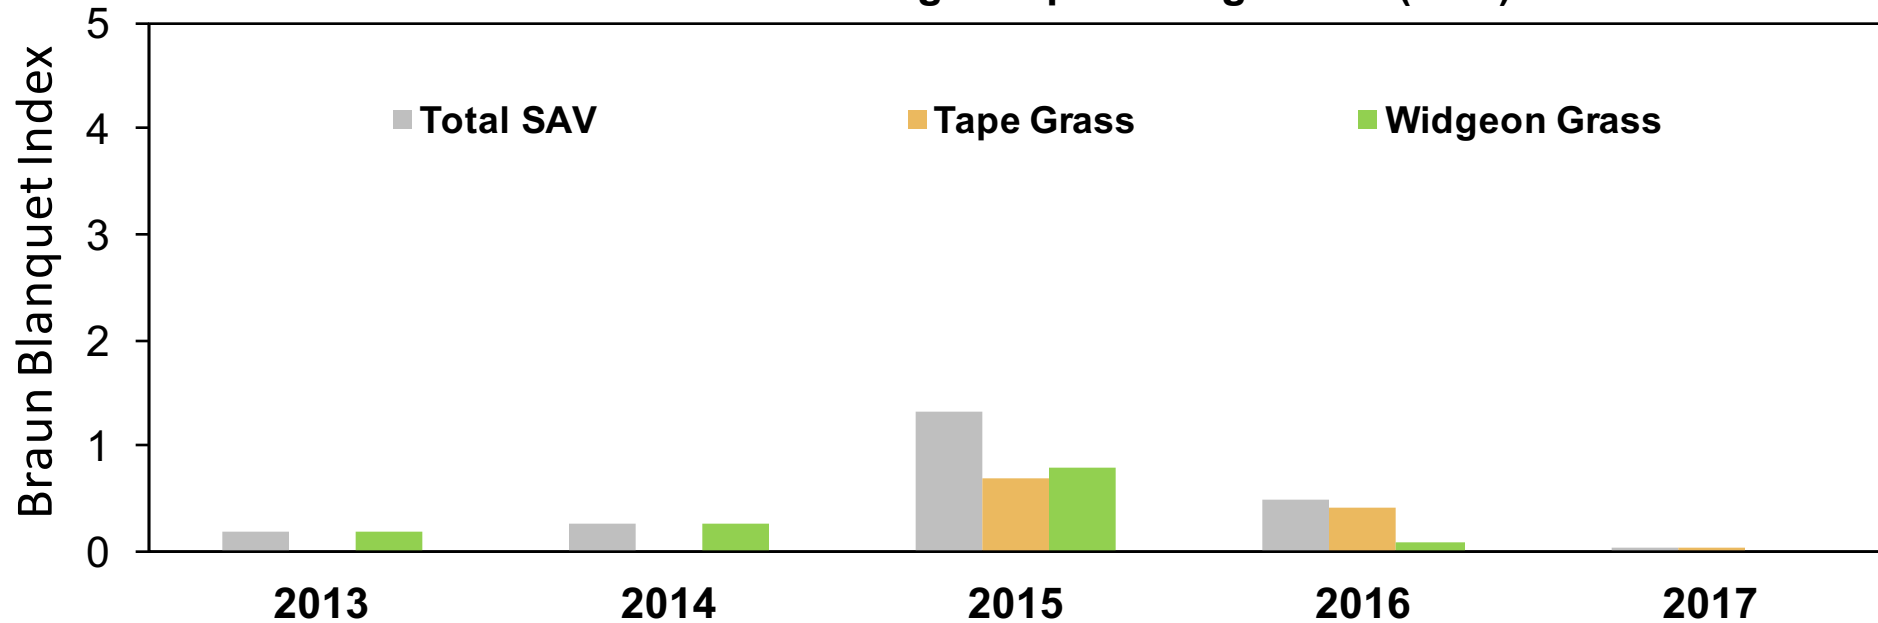
Fall Percent Cover of Submerged Aquatic Vegetation (SAV) at CRE 2

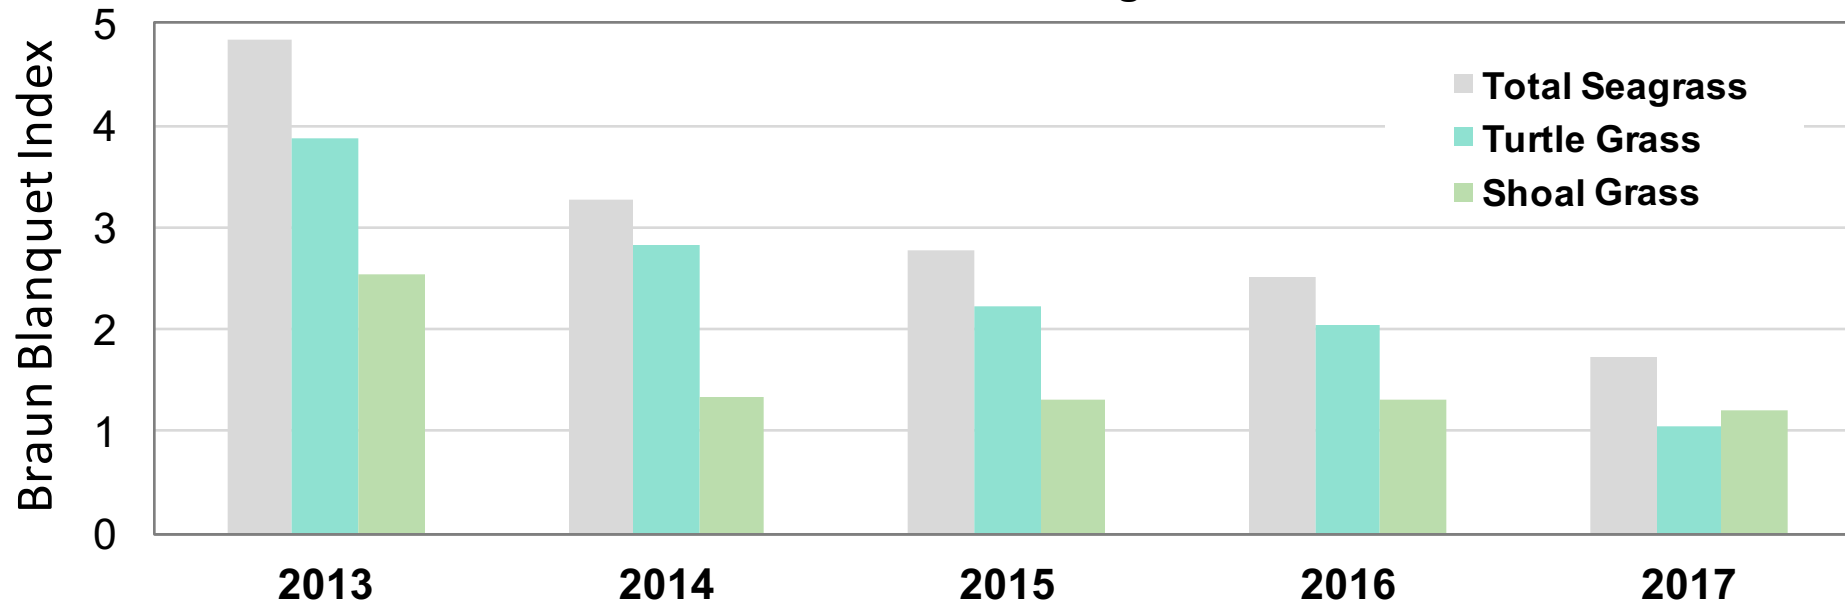
Fall Percent Cover of Seagrass at CRE 8

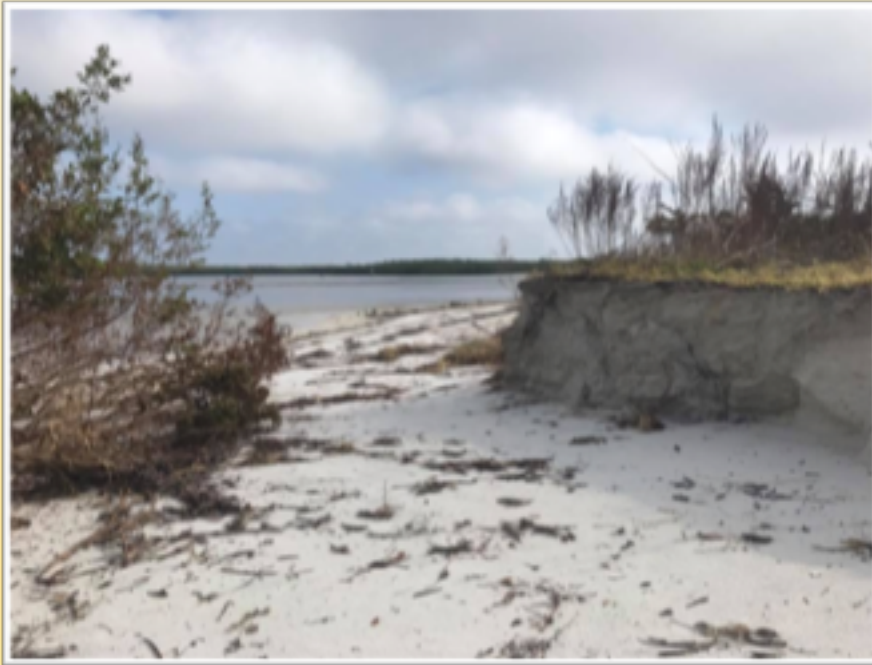
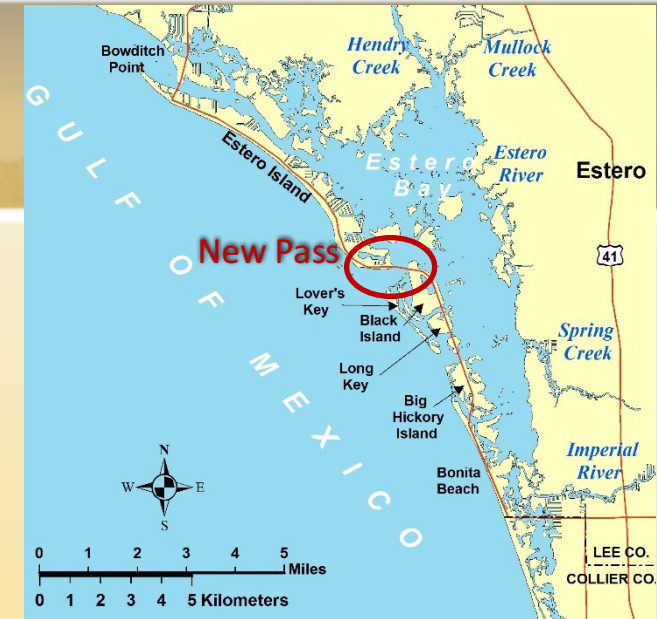
New Pass in Estero Bay

Coastal
re-sculpting
at New Pass
on Estero Bay

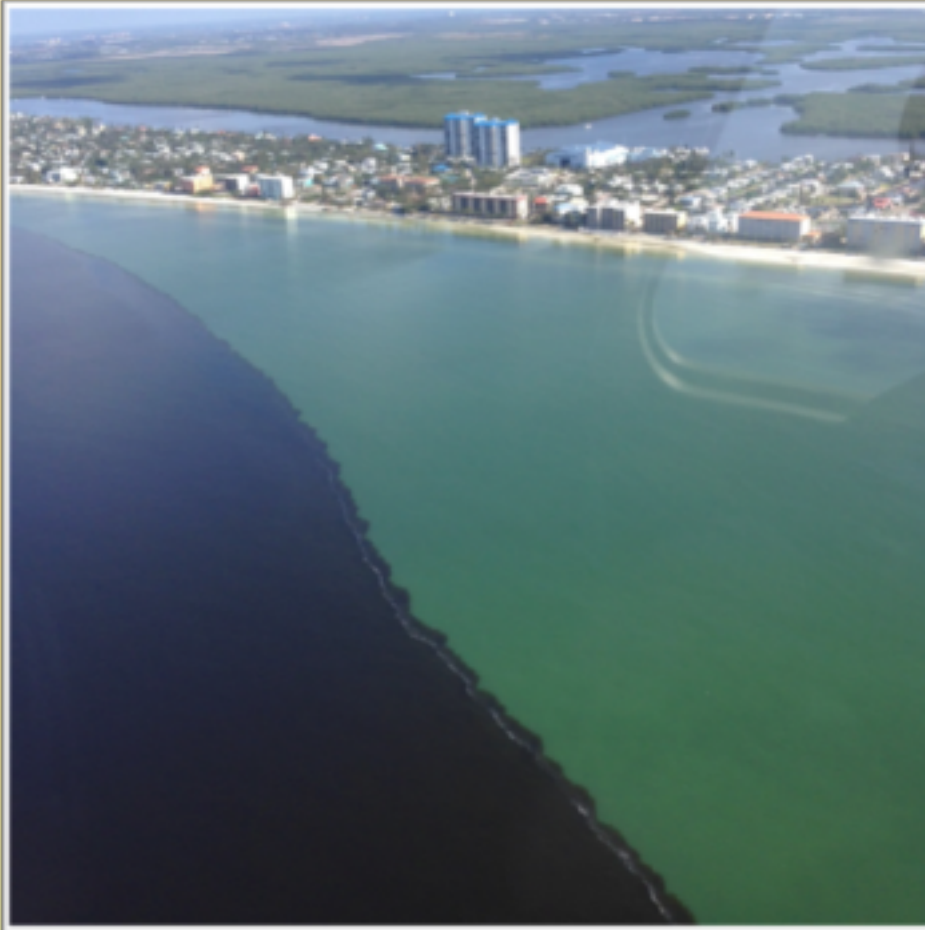
Ft. Myers Beach

Local Basin Watershed Discharges

(No Lake Okeechobee Releases)
